# **Intel<sup>®</sup> Pentium<sup>®</sup> III Xeon<sup>™</sup> Processor Specification Update**

Release Date: July 2001

Order Number: 244460-029

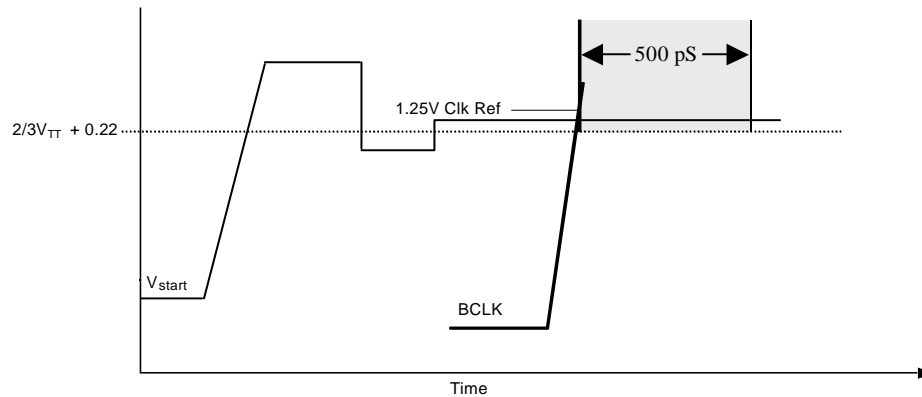
The published AGTL+ AC specification for  $V_{IH(MIN)}$  is  $(2/3 \cdot V_{TT}) + 0.1$  Volts.

Intel has characterized the new AGTL+ AC specification for  $V_{IH(MIN)}$  on the processor's RS0# signal to be:  $(2/3 \cdot V_{TT}) + 0.22$  Volts within 500 picoseconds following the rising edge of BCLK crossing the 1.25-Volt threshold. See below.

**Implication:** The deviation from the published specification results in decreased noise margin on the RS0# processor input. This decreased noise margin has been observed to be particularly detrimental in system environments where the RS0# processor input is being driven by an I/O buffer with a pull-up device (such as a p-channel transistor) that is switched off mid-cycle. Systems that employ I/O buffers that keep the pull-up device on for the entire cycle are significantly less affected by this erratum. The reduction in noise margin may lead to the generation of BINIT# (when enabled) resulting in a system reset, otherwise this condition may lead to a system "hang" condition.

**Workaround:** If a system design cannot meet the specification deviation, the following areas should be carefully examined to assure that additional margin exists in order to compensate for any deficit observed with respect to the newly characterized  $V_{IH(MIN)}$  specification:

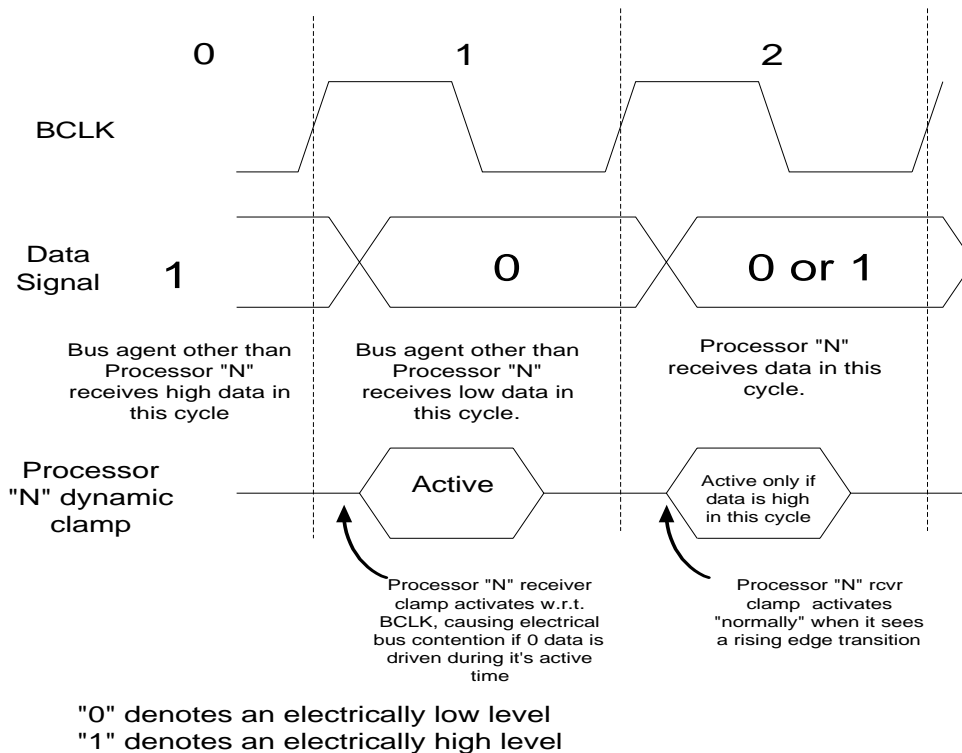
**Problem:** Falling edge ledge push-out and undershoot may be seen on AGTL+ data and data bus ECC signals. The AGTL+ receiver's dynamic clamp circuit activates (i.e. clamps the signal to an electrically high level) in certain cycles when data is driven to an electrically low level by another agent.

**Implication:** This erratum only occurs on a processor that does not receive data in that particular cycle. More specifically, this erratum only occurs when a specific processor does not receive data in the current BCLK period, but receives data in the very next period. Therefore, the processor inducing this falling edge noise (on data and data bus ECC signals) will not actually read the data in that cycle. See below for an illustration of this erratum affecting a processor denoted Processor "N". The falling edge ledges and undershoots may affect the signal quality and/or timing at agents that receive data in that cycle. Therefore, the impact of this erratum is highly dependent on system bus design.

**Workaround:** Evaluate system bus signal quality and timing margin at the valid receiving agent as a result of this falling edge noise. Due to dependence upon system bus design, bus layout may be evaluated to determine the need for improvements in signal quality and timing margin at the valid receiving agent as a result of this receiver-induced falling edge noise.
